VITABLOCS® TriLuxe forte: An effective choice for functional and esthetic restorations

Dr. med. dent. Julio Gomez Paris, Rosario, Argentina

Case study

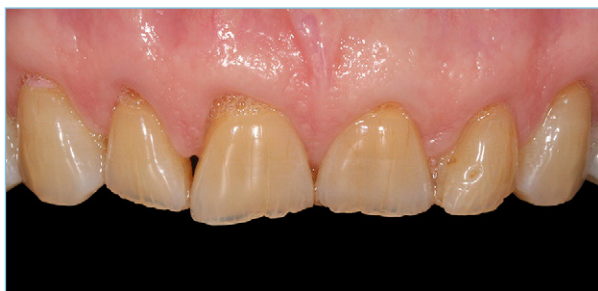
Initial situation: The esthetic zone, damaged as a result of abrasion and erosion in the upper jaw.

A 72-year-old patient came to the practice because she was dissatisfied with the appearance of her teeth. During the initial examination, significant generalized abrasive and erosive processes were evident. The anterior region was characterized by fractures and considerable loss of length. In addition, the patient complained of exposed cervical areas. The patient wanted reconstruction of the hard tooth substance that had

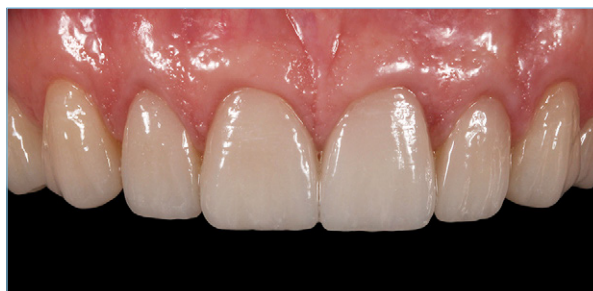
Result: The monolithic restorations fabricated using VITABLOCS TriLuxe forte looked completely lifelike and natural.

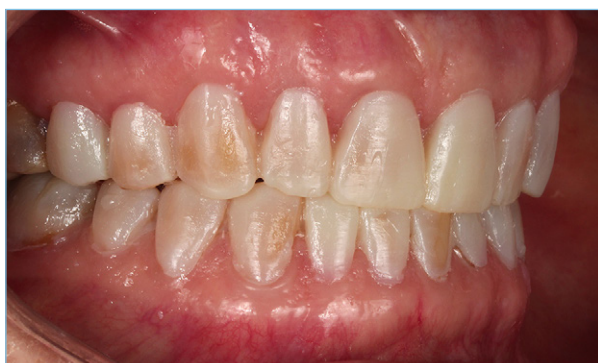
A functional esthetic mock-up simulated the target situation.

the patient's mouth. The silicone key was filled with flowable composite (Protemp 4, 3M, Seefeld, Germany) and repositioned on the dentition. After curing, the composite remained on the dentition when the silicone key was removed: The wax-up became a mock-up that was now used for fine adjustment of the esthetics and function under biodynamic conditions. The modified result was scanned using the CEREC Omnicam (Dentsply Sirona, Bensheim, Germany) and provided the basis for virtual design of the restorations.

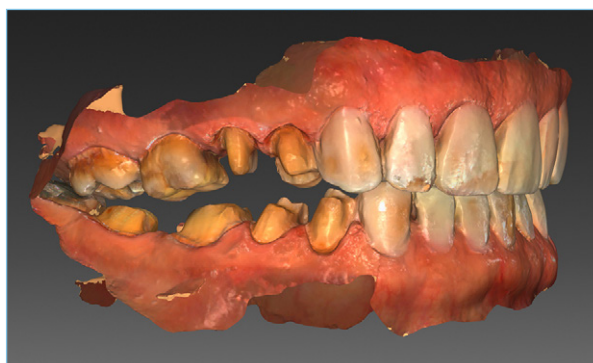
Tooth 16 and 17 in the first quadrant did not require preparation.

To stabilize the occlusion, the posterior region was first reconstructed with crowns and partial crowns made from VITA-BLOCS TriLuxe forte in shade 1M2. In doing so, it became clear that 17, 16, 25, 26 and 27 did not require treatment due to treatment of the antagonist area. After the bite in the posterior region had proven to be stable, the esthetic zone could be reconstructed and a new anterior canine alignment established. The goal here was that no further destructive eccentric forces should impact the molar area. The first step was restoration of the upper anterior region. Following local anesthetic, the mock-up supported gentle preparation that was limited to the enamel area, as well as shaping of the gingival garland by

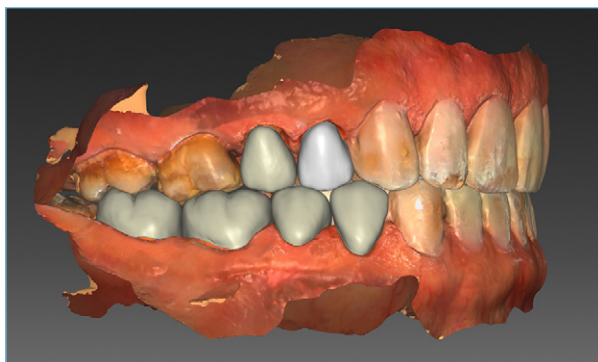
The designs fabricated using VITABLOCS TriLuxe forte in the first and fourth quadrants.

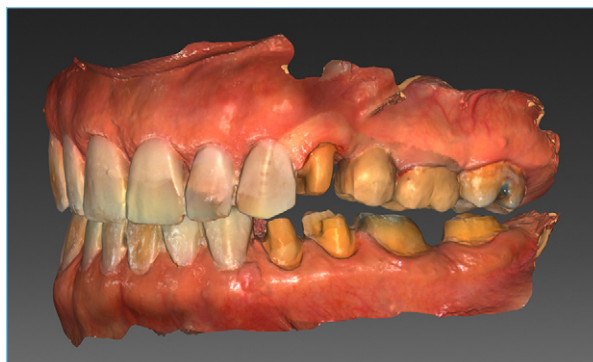
In the second quadrant, tooth 25, 26 and 27 did not require preparation.

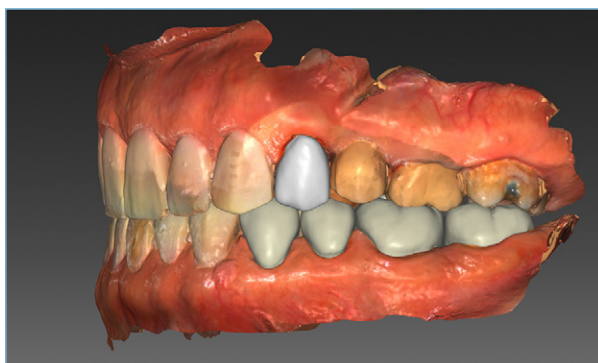
The designs fabricated using VITABLOCS TriLuxe forte in the second and third quadrants.

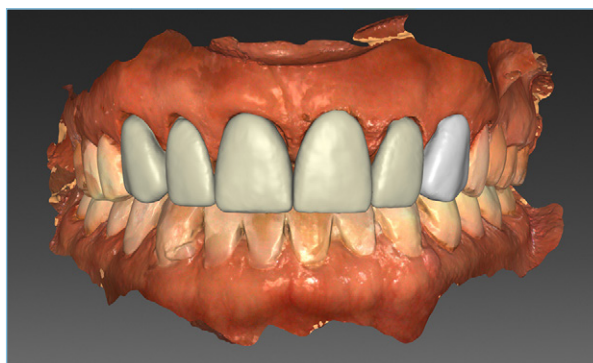
After stabilization of the posterior region, the upper esthetic zone was restored first.

means of a gingivectomy. Following intraoral scanning, the dataset was transferred to the inLab CAD software (Dentsply Sirona, Bensheim, Germany). During the design process, the previously digitized mock-up was also used here to provide a morphological basis. CAD/CAM-supported fabrication of the veneers was carried out using the X5 milling unit (Dentsply Sirona, Bensheim, Germany). The restorations were finalized using fine diamonds and a rubber polisher and then characterized and glazed using the VITA AKZENT Plus stain system. Following fully adhesive placement of the veneers using RelyX Veneer (3M, Seefeld, Germany) in the upper jaw, restoration of the esthetic zone in the lower jaw was carried out in the same way.

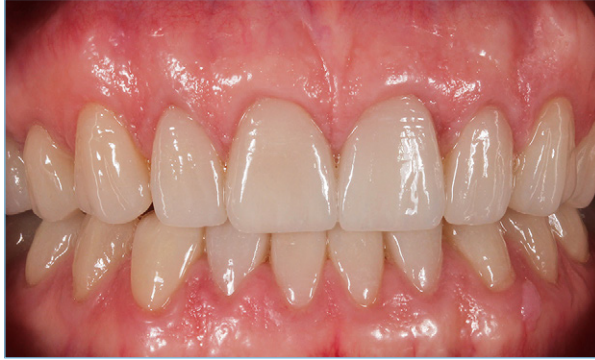
The treatment result 18 months after placement.

To ease pressure on the stomatognathic system at night and to protect the restoration, a front-canine-guided splint was also fabricated for the upper jaw. The restorations were intact 18 months after placement and the patient was free from any symptoms. VITABLOCS TriLuxe forte proved to be an effective booster in treatment with total reconstruction. As a result, it has the potential to make this comprehensive treatment beneficial for an even larger group of patients. This type of restoration

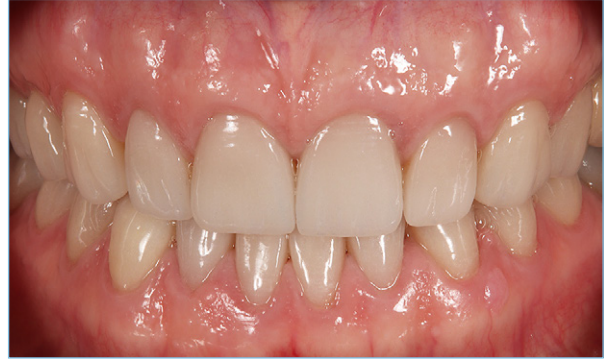
Even after 4.5 years, all restorations were perfectly intact.

will become increasingly important in the future, particularly as our society continues to get older and corresponding prophylaxis ensures that we retain our own teeth into old age. In this case, the patient was completely satisfied with the rapid nature of her treatment and the esthetic result. Even after 4.5 years, all restorations proved to be fully intact during a follow-up examination. There was no uncontrolled abrasion or parafunction in the incisal and occlusal areas.

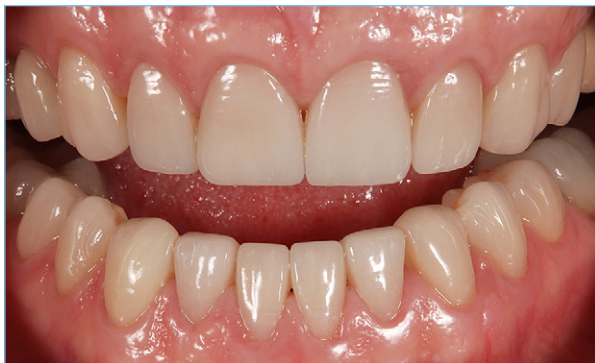
After 4.5 years, there was no uncontrolled abrasion or parafunction in the incisal or occlusal areas.
