VITABLOCS® TriLuxe forte

The center of the esthetic zone made of VITABLOCS TriLuxe forte

Dr. Julian Conejo, University of Pennsylvania, School of Dental Medicine, Philadelphia, USA

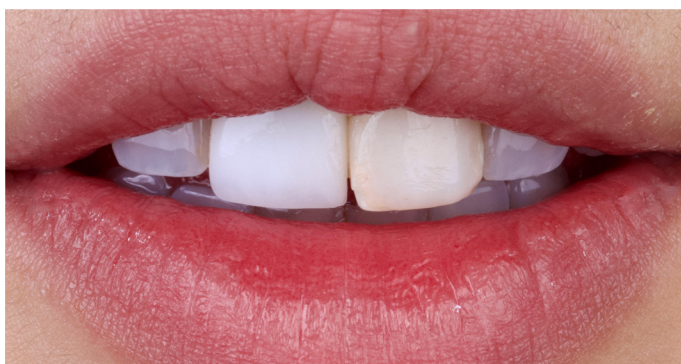
The initial situation with the unattractive crowns on teeth 11 and 21.

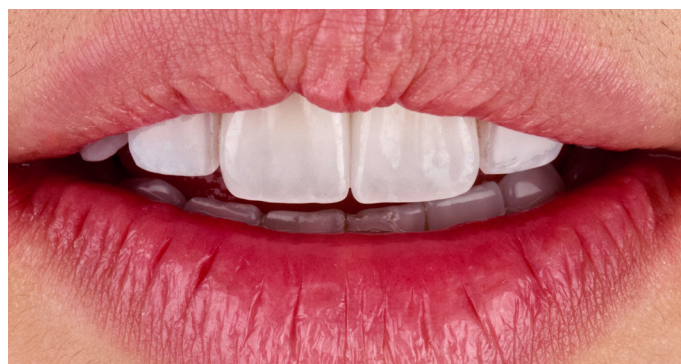
Treatment result with the new crowns made of VITABLOCS TriLuxe forte on 11 and 21.

(Kurary Noritake, Tokyo, Japan). The final images show that the VITABLOCS TriLuxe forte blanks selected for the patient resulted in restorations that absolutely resembled natural teeth. The monolithic restorations blended harmoniously into the center of the maxillary front. Consideration of the esthetic rules and the natural morphology in combination with the right choice of material were decisive factors in the success of the treatment.

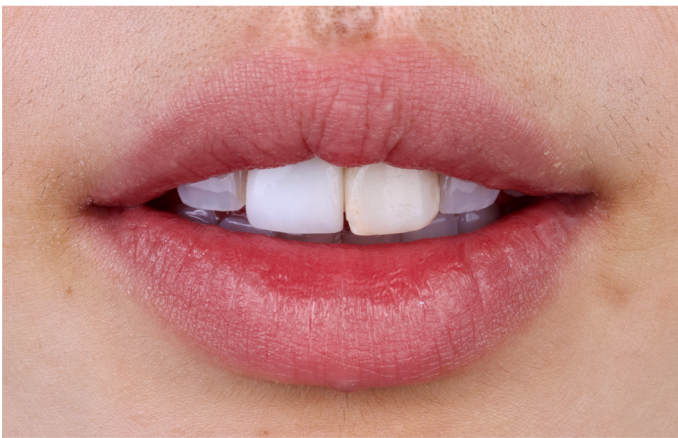
Fig. 1: The initial situation with the unattractive crowns on teeth 11 and 21.

A 25-year-old patient visited the dentist's office because she was dissatisfied with the esthetics of her crown restorations on 11 and 21. During the clinical examination, a deficient all-ceramic crown was observed on tooth 11 and a VMK crown on 21. From a morphological perspective, both crowns appeared too square and too massive. The incisal edges did not harmonize with each other, or with tooth 21 and the course of the lower lip. The all-ceramic crown on 11 was far too opaque compared to the natural dentition and therefore appeared lifeless. The shade of the VMK crown on 21 did not match

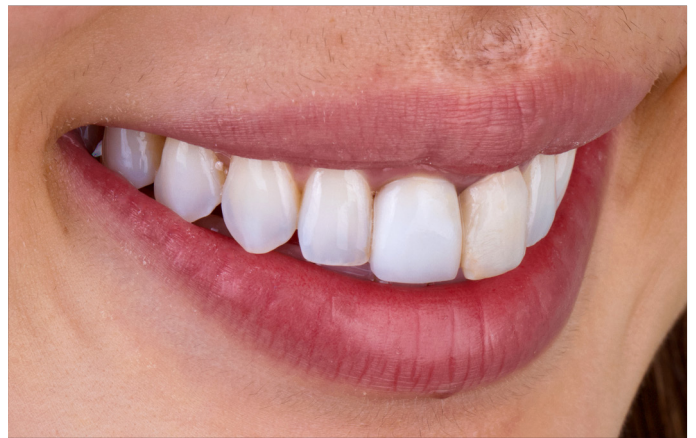
Fig. 2: The two crowns on 11 and 21 did not harmonize morphologically with the dental arch.

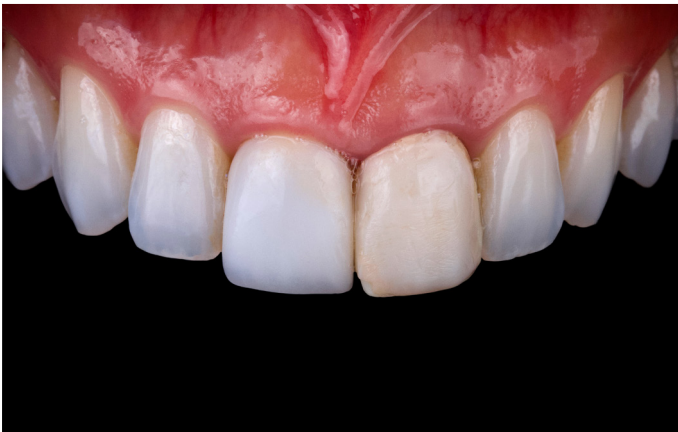
Fig. 3: The restorations looked lifeless. The shade effect on tooth 21 in particular did not match.

the restoration of the adjacent tooth or the remaining natural tooth structure. The decision was made to provide the two teeth 11 and 21 with new crowns using the digital workflow. VITABLOCS TriLuxe forte was selected as the restoration material because the blanks have a natural appearance,⁶ are true to the VITA shade standard⁷ and have a natural shade gradient.⁸ The successful use of feldspar ceramics in the anterior region has also been proven several times in clinical studies.^{9,10}

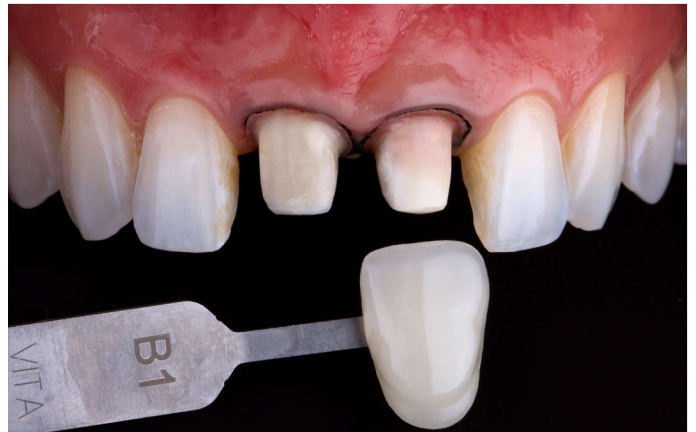
Fig. 4: The tooth shade was determined using the VITA classical A1 - D4.

The crowns were slit and removed from the stumps following local anesthesia. After careful subsequent preparations and cleaning of the stumps, retraction cords were placed. Tooth shade determination followed with VITA classical A1 – D4. The shade B1 was chosen and was documented in photographs in the laboratory using the corresponding shade tabs for orientation. An intraoral scan with Primescan was used to create a virtual model in the CEREC Software 5.1, which could be used to design the crowns made of VITABLOCS TriLuxe

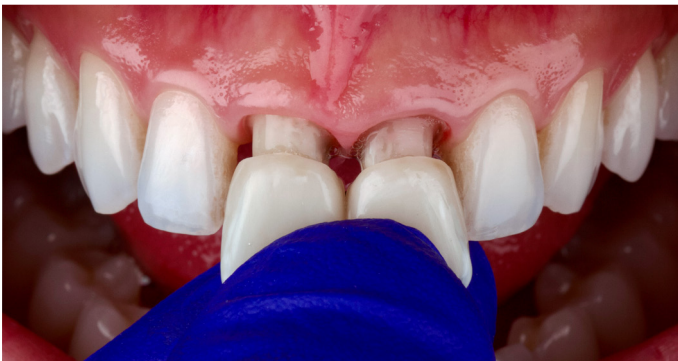
Fig. 7: After finishing, the two crowns were clinically tried in.

After the crowns had been separated from their attachments, they were ground back and the micromorphology was worked out with fine diamonds. Rubber polishers were used for smoothing. Minimal characterizations and the glaze were then applied using the VITA AKZENT Plus stain system. This was followed by an intraoral fit check with blue silicone. Finally, the restorations were conditioned on the lumen side with hydrofluoric acid and silane. Fully adhesive cementation was carried out using the universal bonding system PANAVIA V5

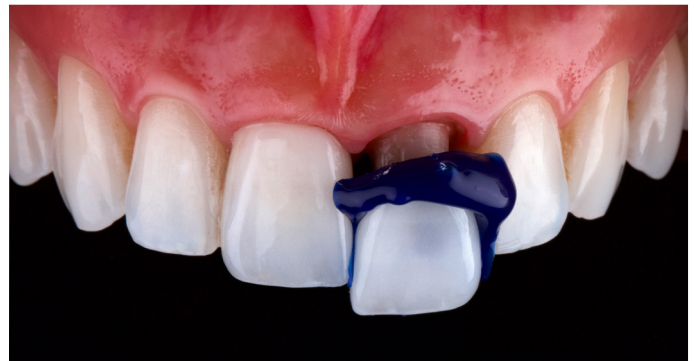
Fig. 8: A blue silicone was used to check the fit on the lumen side.

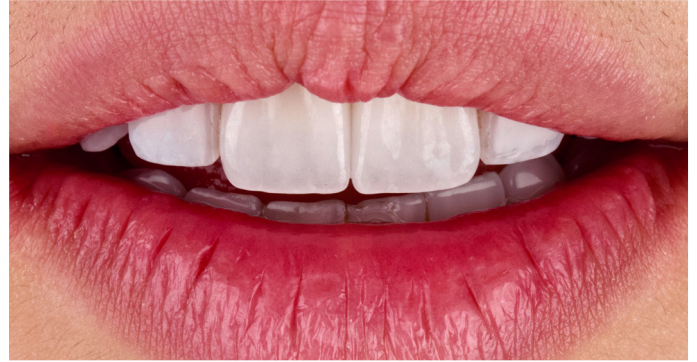
Fig. 10: The shade effect, morphology and texture harmonized with the natural teeth and lip contour.
